TREE ROOTS

in your sewer pipes

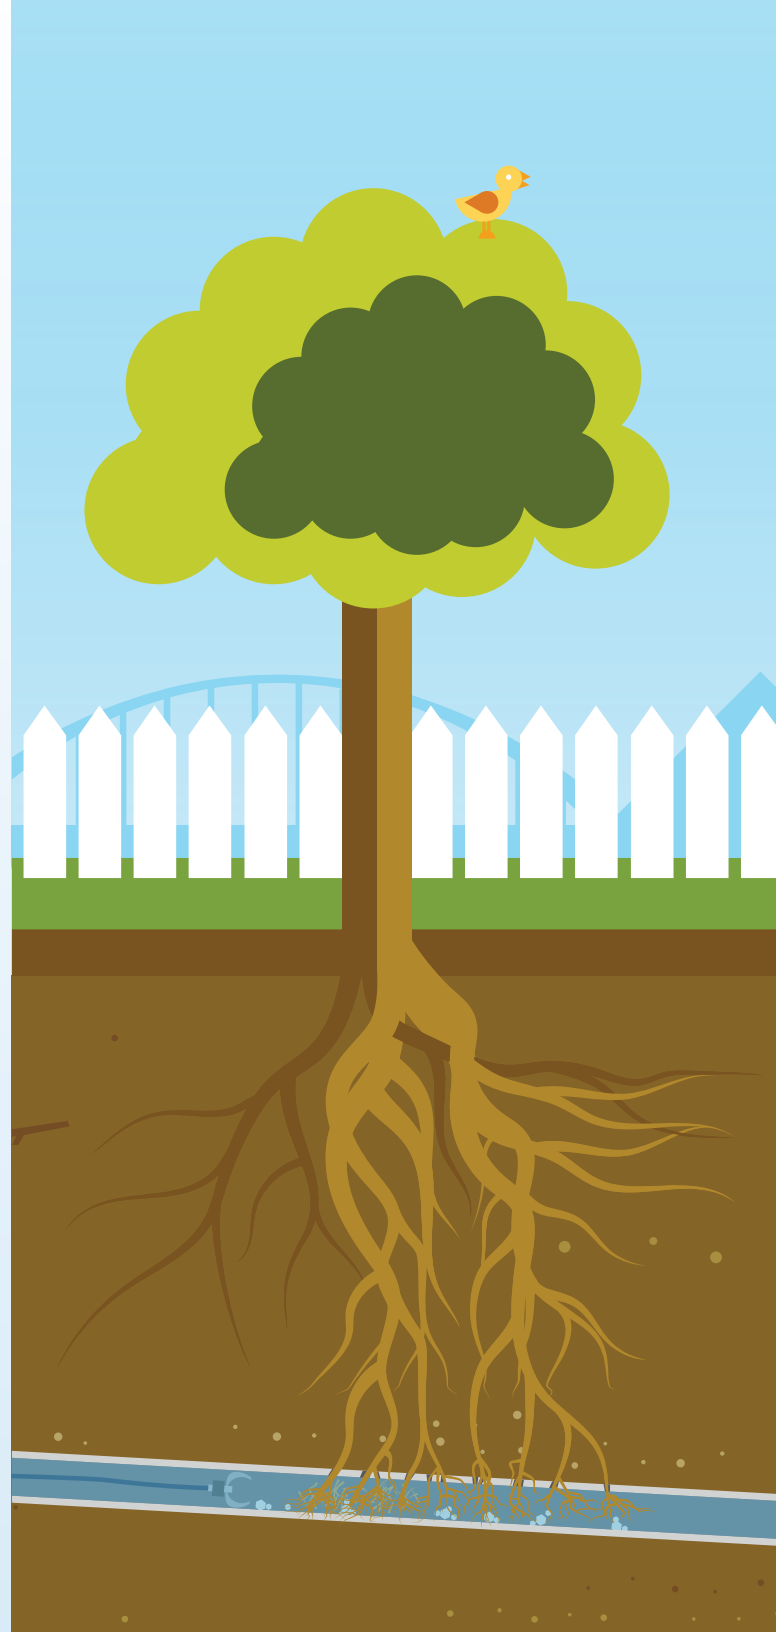
Roots from trees growing on private property and on boulevards throughout Edmonton can cause flooded basements and damage sewer pipes. Homes built before the early 80's generally have sewer services constructed with clay tile pipe. Sewer water may leak out of the joints in these pipes providing trees with moisture to grow and thrive in the warm, nutrient-rich soil surrounding the pipe.

Once a sewer pipe is penetrated by tree roots it will continue to grow and separate the joint allowing more sewer water to escape creating a great environment for the roots to spread. Roots will also act as a filter in the sewer pipe allowing water to pass through but not any other items. Once enough material has collected at the roots the water flow is restricted causing it to back up in your basement.

Tree roots in pipes can be managed by auguring through the sewer pipe, this can be done by a certified plumber or by EPCOR. This is not a long term solution as the roots will continue to grow back and may eventually cause the pipe to collapse. This problem can be eliminated by relining or replacing the pipe.
